UNITED STATES ENVIRONMENTAL PROTECTION ACENCY REGION V US EPA RECORDS CENTER REGION 5

DATE: September 5, 2002

SUBJECT: Acme Solvent Site Visit--Pipe(s) Near South Boundary

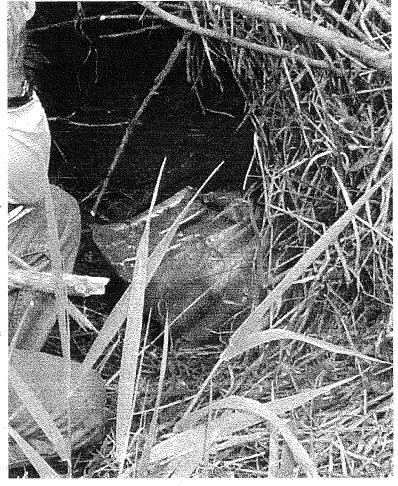
The picture above shows the end of the pipe on the Acme Solvent property; this is part of one of several pictures that I took. I did not look closely at the corrugated pipe to see what material it might be; it has been described as stainless steel, but it may not be. Note that the end of the pipe has been slightly damaged, but there is still a wide opening. Note that the pipe is angled upward

from the ground; it is pointing approximately toward the northwest so that at this point it appears to be coming from the field south of Acme Solvent. No liquid was coming from the pipe and there were no signs of liquid present.

I suggest that, at least for a few months, someone periodically (every one to two weeks) check the pipe(s) to see if any discharge of liquid is occurring. If a discharge is seen at one opening and not the other, this needs to be noted. It would be especially useful to check the pipe(s) after any fairly heavy rainstorms. If a regular discharge is observed, I suggest that the discharge be sampled and analyzed for appropriate parameters to determine if the liquid is unacceptably contaminated. One thing that should be checked with any sampling is whether it appears that the liquids at both pipe openings are the same or different. I also suggest that the existence of the pipe(s) be noted in the next five-year review for the Acme Solvent site and that any changes from the observations reported here be noted there.
